ENVIRONMENTAL FEATURES

The River and Shoreline

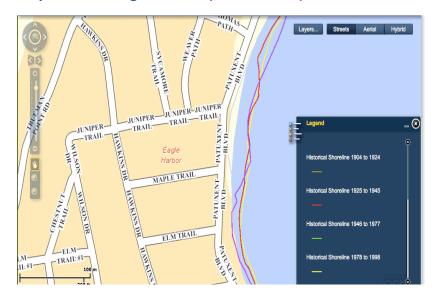
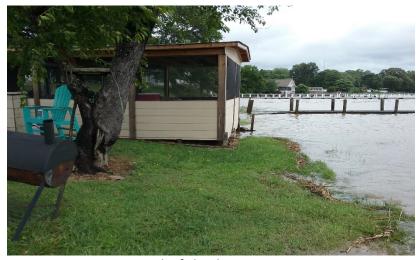
Map 11: Shrinking Shoreline (1904 to 1998)

Evidence of Beach/Shoreline Erosion

Over time erosion has redefined the shoreline, shrinking it in most locations; expanding it through accretion (the gradual accumulation of sediment) in others. While the movement of water, waves and wind and the resulting erosion of the shoreline and silt buildup are natural processes, there is increasing evidence that climate change has accelerated this process. Map 11 shows evident of this process and conditions in Eagle Harbor. For the most part, the shoreline has retreated over the last century and the process is accelerating.

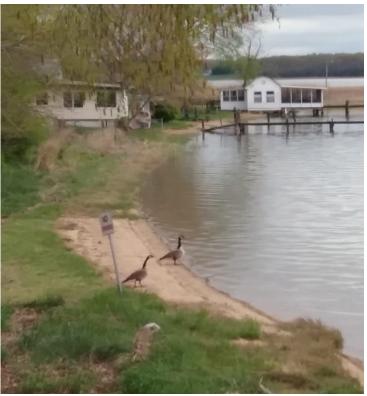
Accessory Structure at Risk of Flooding

Evidence of Shoreline Erosion and Risk to Existing Structure

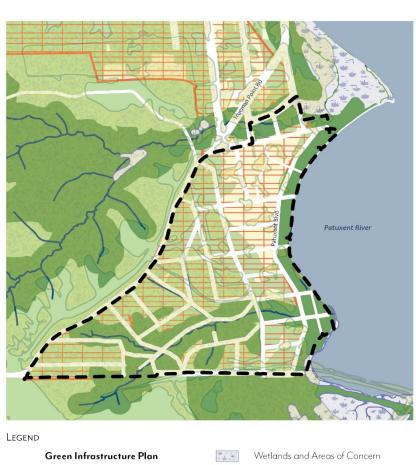
Map 12: Green Infrastructure (2005 Plan)

In the 2005 plan, Regulated Areas are concentrated along the shoreline including portions of Trueman Point, and along Coleman Creek (Map 12). Most of Eagle Harbor at that time is classified as Evaluation Areas; the rest, as Network Gap areas -important to establishing a complete green infrastructure network. In the 2017 plan, Regulated Areas still define the coastline and Coleman Creek. However, this category now includes the entire Trueman Point (Map 13). Evaluation Areas still define most of the Town. While Network Gaps are not identified in 2017, through a future master plan for the subregion, or development processes, Network Gaps identified in 2015 will likely be reestablished.

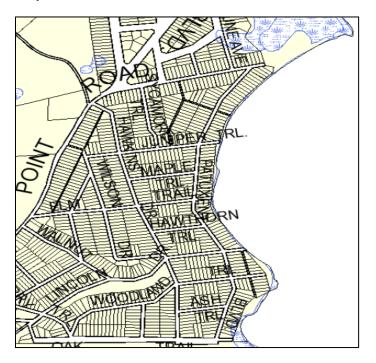
Map 14: Wetlands and Areas of Concern

Wetlands cover most of Trueman Point and most of the coastline in Eagle Harbor. (Map 14.) Beyond Trueman Point,

the largest wetlands are in the southeasternmost corner of the community, on private property. The State has determined that these wetlands may contain certain rare, threatened and endangered species or unique habitat that should receive special attention and protections. As such these areas are labeled Areas of Concern and are protected from development through the 100-foot Buffer Zone.

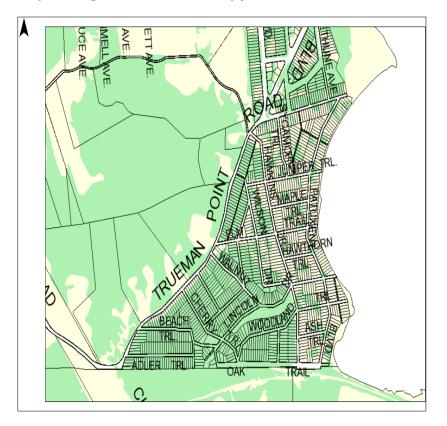
Map 15: Eagle Harbor Tree Canopy

Eagle Harbor has an extensive tree canopy, primarily in the uptown area and along Trueman Point Road. The tree canopy is spotty in the rest of Town, especially along Patuxent Blvd and many of the east-west Trail streets in Downtown Eagle Harbor.

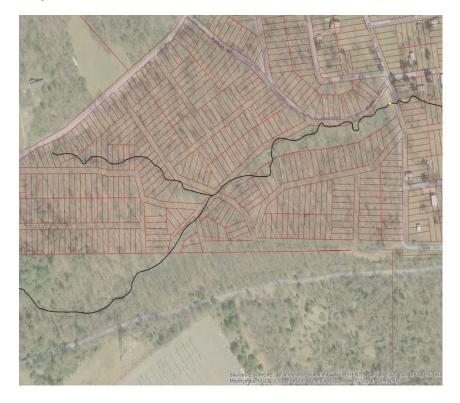
Map 16: Coleman Creek

Coleman Creek, named after a prominent Town resident, runs from Uptown to Downtown Eagle Harbor, in the southern section of Town (Map 16). It runs through both developed and underdeveloped property and makes its way to the Patuxent River via a culvert beneath Patuxent Blvd. The width and depth of the creek vary along its length, and changes over time, reaching its shallowest point about 40 to 50 feet from the river.

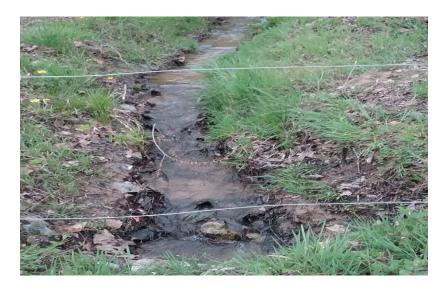
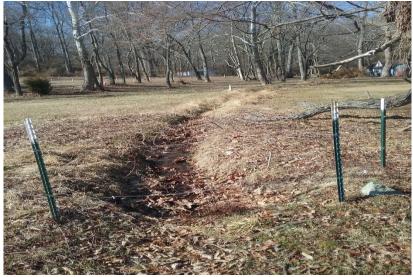
Coleman Creek East (Top) and West (Bottom) of Patuxent Blvd

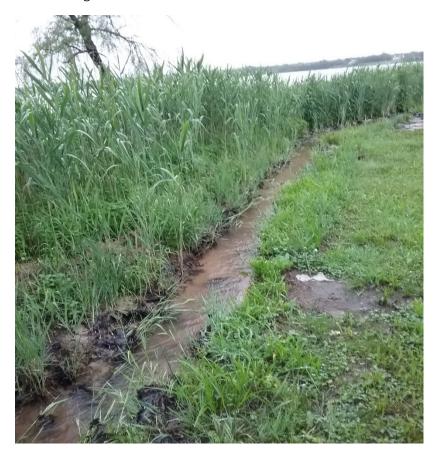
A wall of vegetation grows up along the creek bank east of Patuxent Blvd that must be cut back regularly to avoid filling in the creek. Sand also regularly travels in the creek, also necessitating regular dredging to keep stormwaters from overflowing the bank.

Wall of Vegetation along Coleman Creek east of Patuxent Blvd

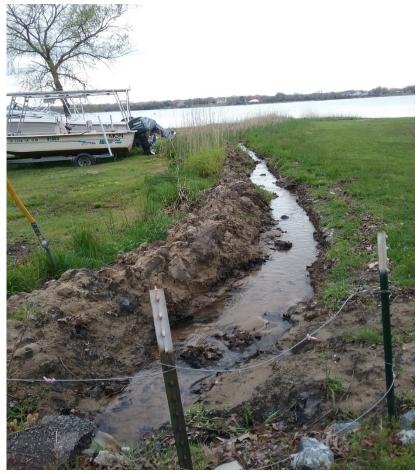
Coleman Creek East of Patuxent Blvd after Dredging

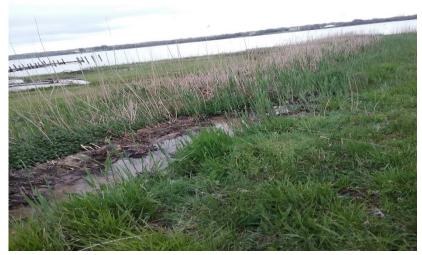
Shallowness of Coleman Creek Near the River

The shallowness of Coleman Creek close to the river coupled with the vegetation along the coastline at this location can serve to filter stormwater to some degree as it flows into the river. However, the quality of the stormwater reaching the river is still an issue. Stormwater picks up, carries and deposits

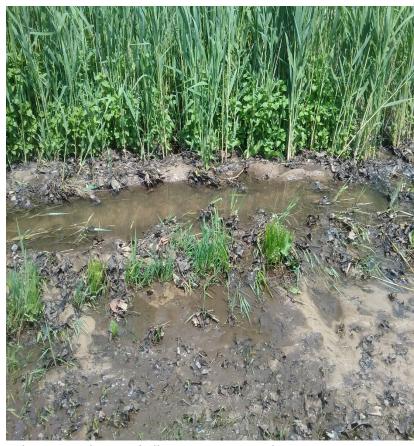
Coleman Creak at its Shallowest Point Near the Patuxent River
